**Kineticcorp**<sup>TM</sup>  
Forensic Engineering and Visualization

Case Name: *Bacho v. Rough Country, LLC*

As requested, Kineticcorp investigated and reconstructed a multiple vehicle crash that occurred at approximately 8:06 PM on December 22, 2012. The crash occurred at the intersection of Lower Fayetteville Road and Newnan Crossing Bypass in Newnan, Georgia. A southbound 1999 Chevrolet K1500 pickup truck, driven by Taylor Long, failed to stop at a red light and impacted an eastbound 2012 Toyota Sienna driven by Natalie Bacho. According to the police report and phone records, Mr. Long was on the phone with his girlfriend before and during the accident.

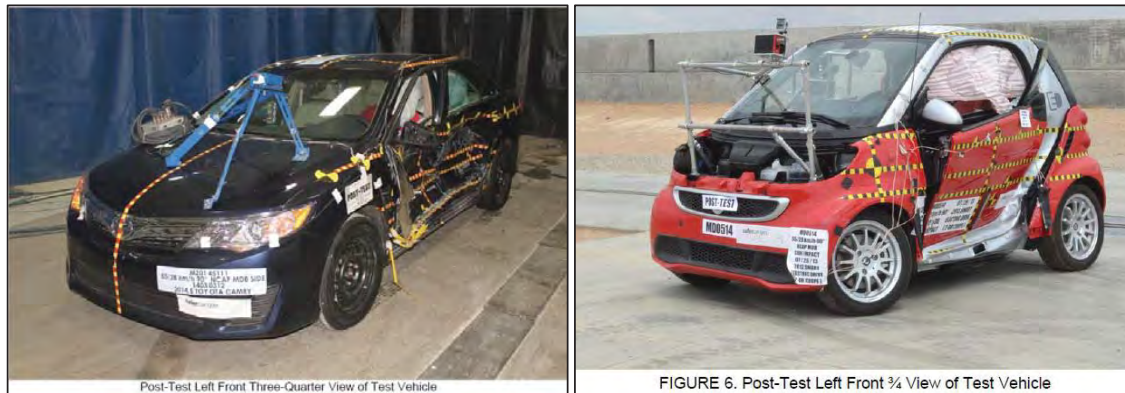
Figure 33 – NCAP Side Impact Test Photographs: Toyota (left) and Smart Car (right)

Crash Test Analysis: Pages 31 through 34 of Dr. Renfroe's report contains a discussion comparing two New Car Assessment Program (NCAP) side impact tests. These tests pertain to a 2014 ½ model year Toyota Camry (test # 8560) and a 2013 Smart Electric 2 Door Coupe (test # 8312). Figure 33 below contains photographs from the respective crash test reports, the same photographs from page 33 of Dr. Renfroe's report.

Dr. Renfroe uses these crash tests to illustrate that impacts involving wheels reduce intrusion. What Dr. Renfroe does not acknowledge is that when vehicles deform, their structures absorb energy during a crash, reducing the accelerations experienced by the occupants. In the NCAP crash tests, the accelerations experienced by the dummies were measured. Figure 34 below is a series of data plots measuring the resultant head accelerations for each test. The first image in the graphic shows the dummy head acceleration from the Toyota test, the second image in the graphic shows the dummy head acceleration from the Smart Car test. The image below is a combination of both plots. As seen in the figure, the peak head acceleration in the Toyota crash test was 31.7 G's. The peak head acceleration in the Smart Car crash test was 51.7 G's, 20 G's (63%) more than the Toyota test. The crash pulse duration from the Smart Car test was also significantly shorter than the Toyota crash pulse. Dr. Renfroe implies that a reduction in intrusion results in increased occupant safety, however Dr. Renfroe neglects to consider the effects of energy management as the vehicle crumples and absorbs energy. As shown above, making a vehicle stiffer can substantially increase the accelerations acting on the vehicle's occupants.

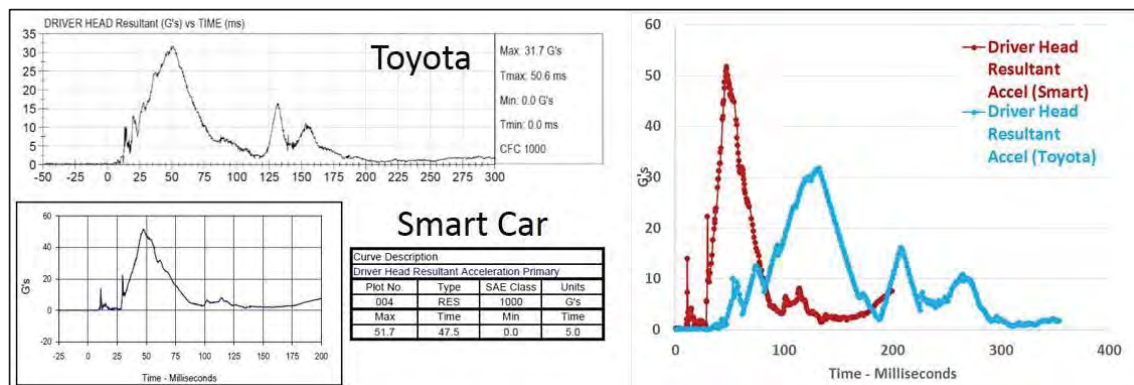
Figure 34 – NCAP Side Impact Test: Resultant Head Acceleration

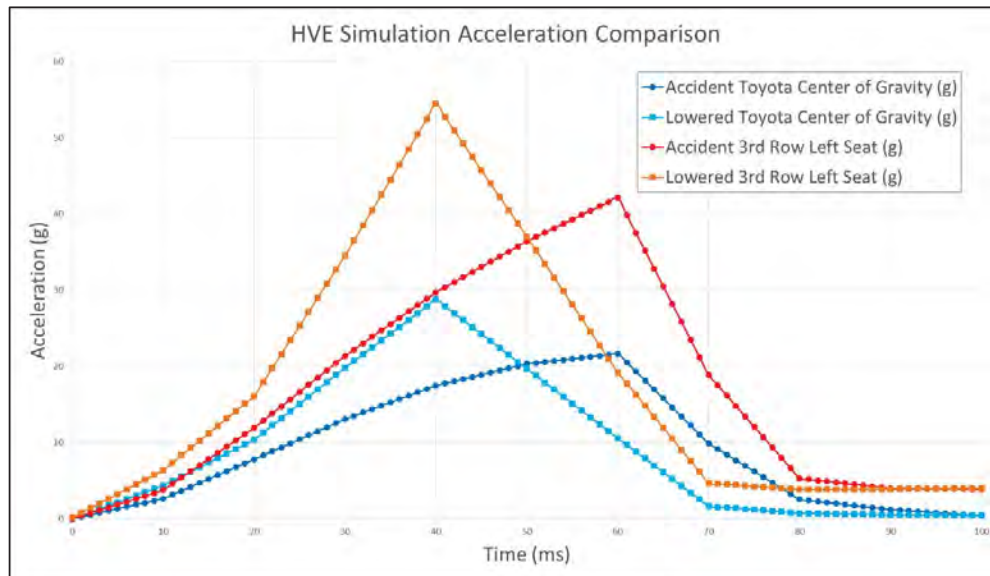
The resulting simulation of the lowered Chevrolet was similar in most respects to the subject accident simulation. Kineticorp used the HVE-3D simulation to evaluate the accelerations that would have been experienced by the vehicle and at the seating location of Abigail Bacho. The accelerations seen in the simulation of the lowered Chevrolet were more severe than those seen in the subject accident simulation. Figure 36 is a plot comparing the total accelerations during the first 100 milliseconds for both HVE-3D simulations for the vehicle center of gravity and the third row left seated position.

Figure 36 – HVE-3D Accident Acceleration Comparison Plots

As seen in the figure, due to the increased wheel stiffness the peak acceleration of the vehicle was increased from about 22 to about 29 times gravity. Similarly, Abigail Bacho would have experienced greater peak accelerations increasing from 42 to nearly 55 times gravity.

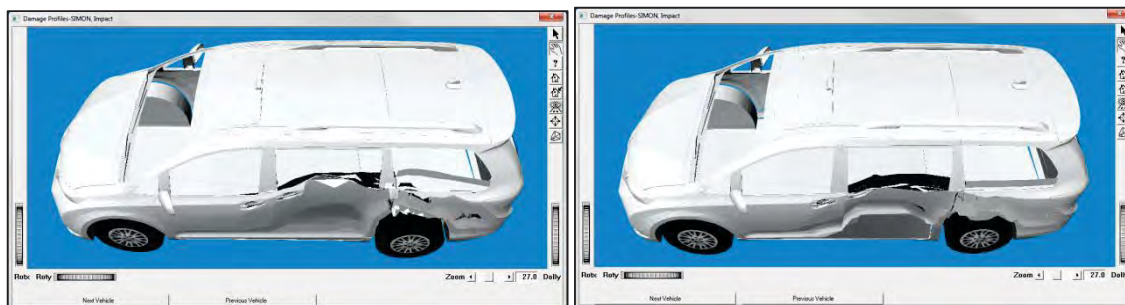
Figure 37 contains views of the Toyota vehicle model at the end of the two simulation runs. As seen in the images the deformation is not significantly different when comparing the subject Toyota on the left to the modified Toyota on the right. This is due in part to the impacting Chevrolet vehicle deforming around the stiffened wheel. Had the Toyota's wheel been able to deform in the simulation of the lowered Chevrolet, it is likely that the deformation patterns would have been almost identical.

Figure 37 – HVE-3D Toyota Model Deformation  
Subject Accident Simulation (left) vs. Lowered Simulation (right)
